# Environmental Projects: Volume 4

## Asbestos Survey

Goldstone Deep Space Communications Complex

Jet Propulsion Laboratory  
California Institute of Technology  
Pasadena, California

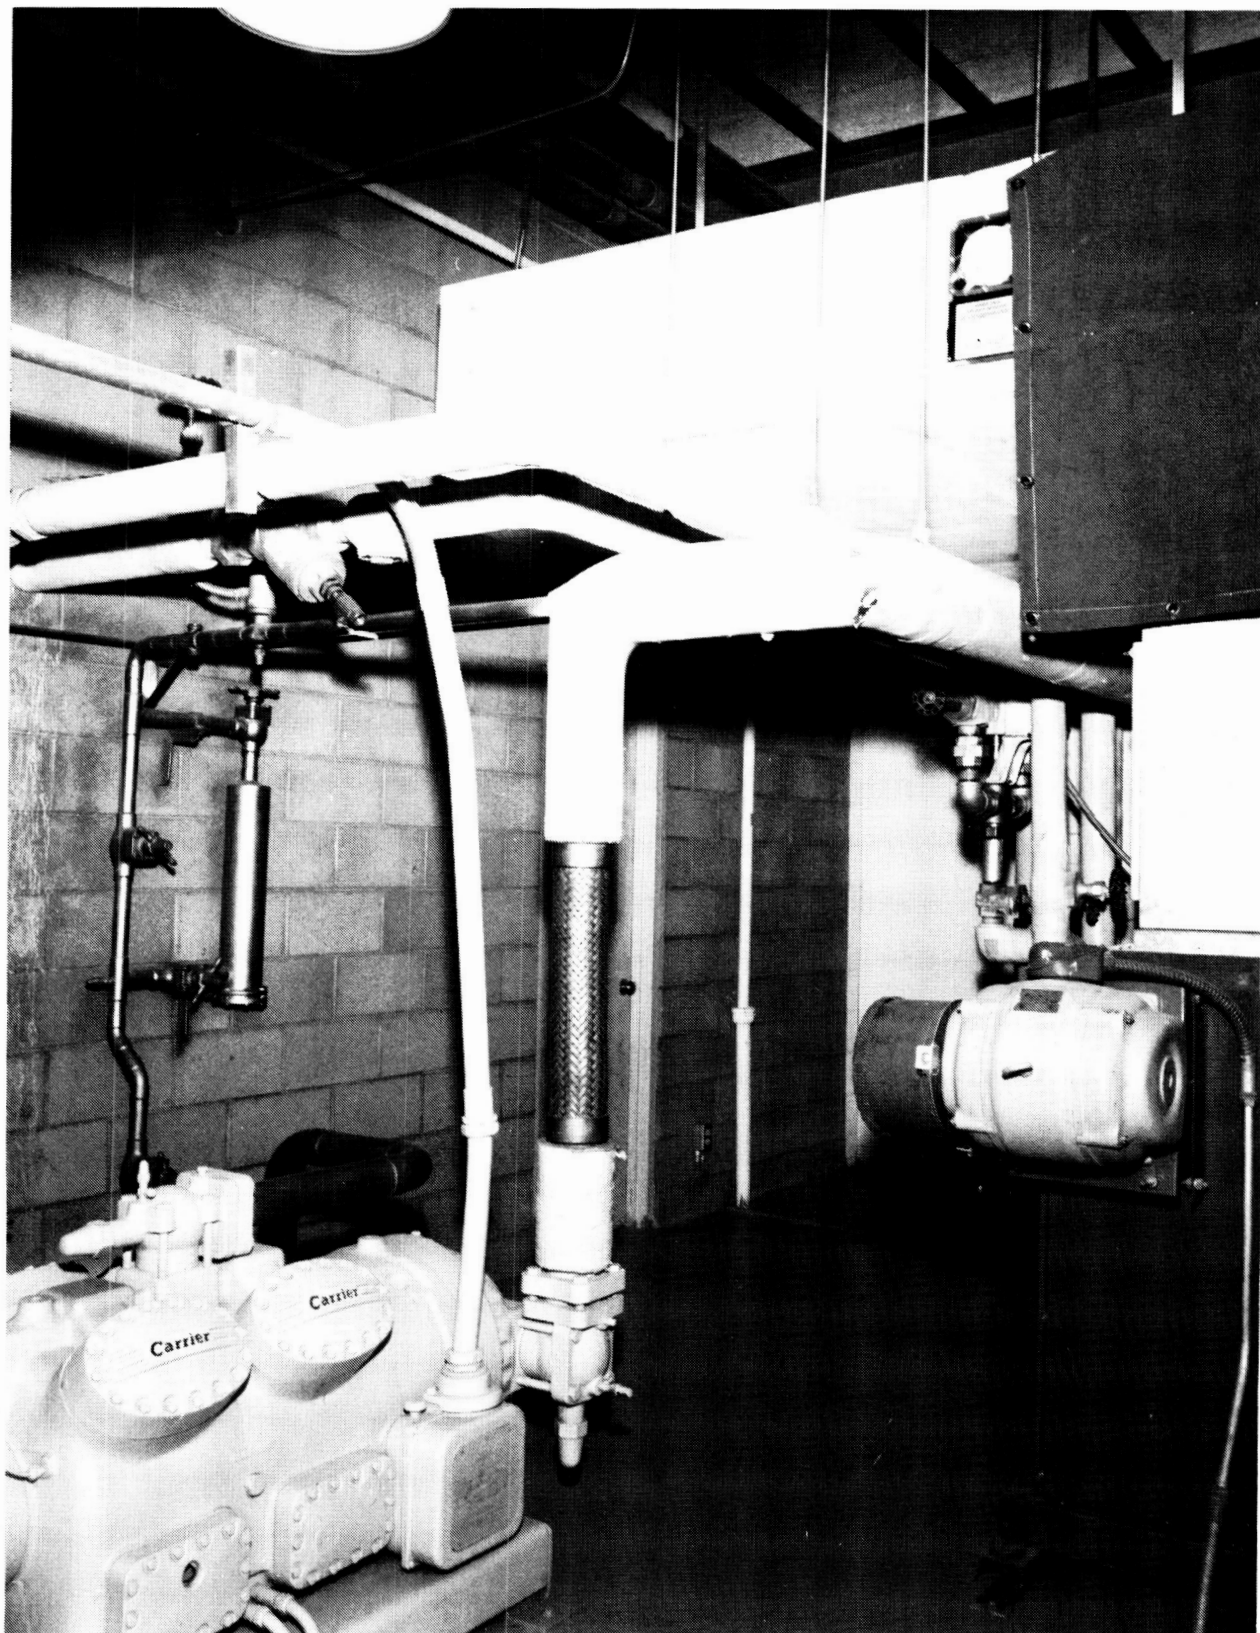
Figure 10. Echo Site: Building G-21, Mechanical Equipment Room 127, Asbestos-Containing Pipe Lagging.

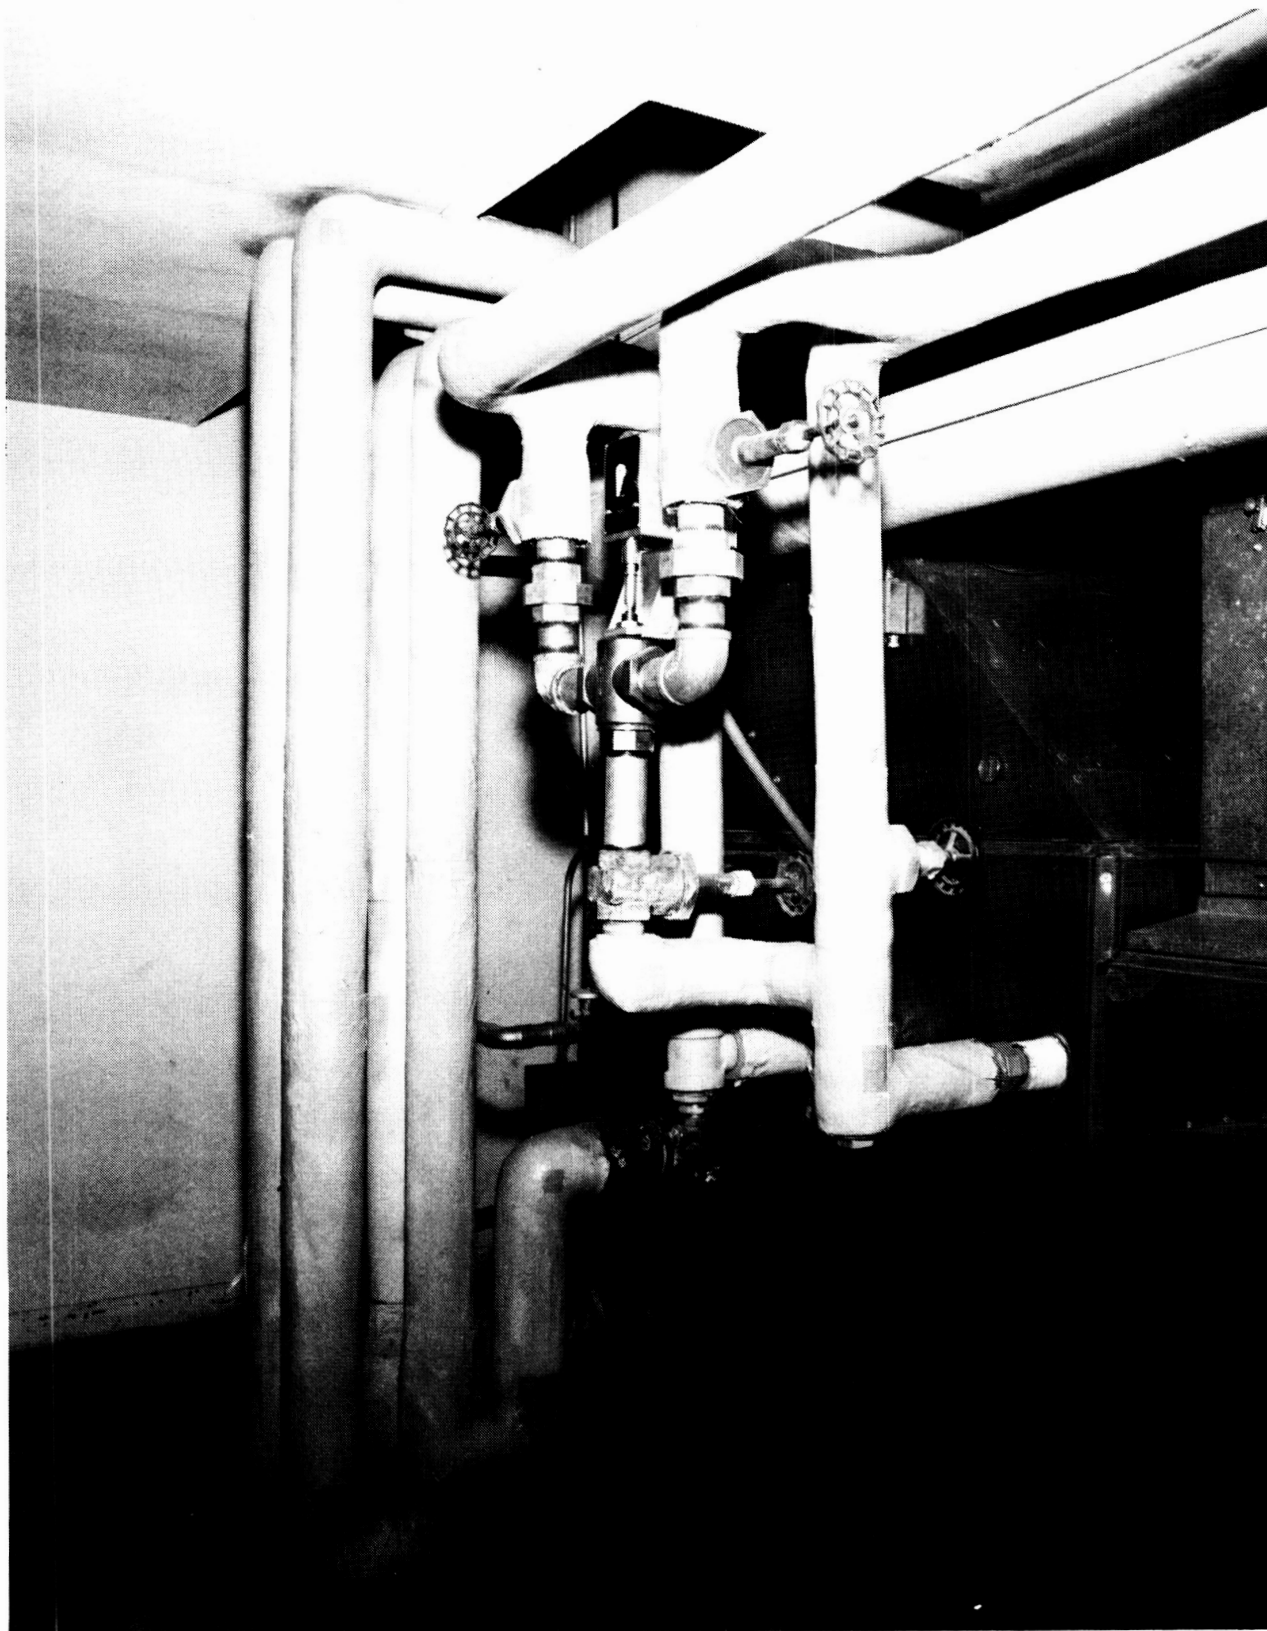
Figure 11. Echo Site: Building G-21, Mechanical Equipment Room 127,  
Asbestos-Containing Pipe Lagging.

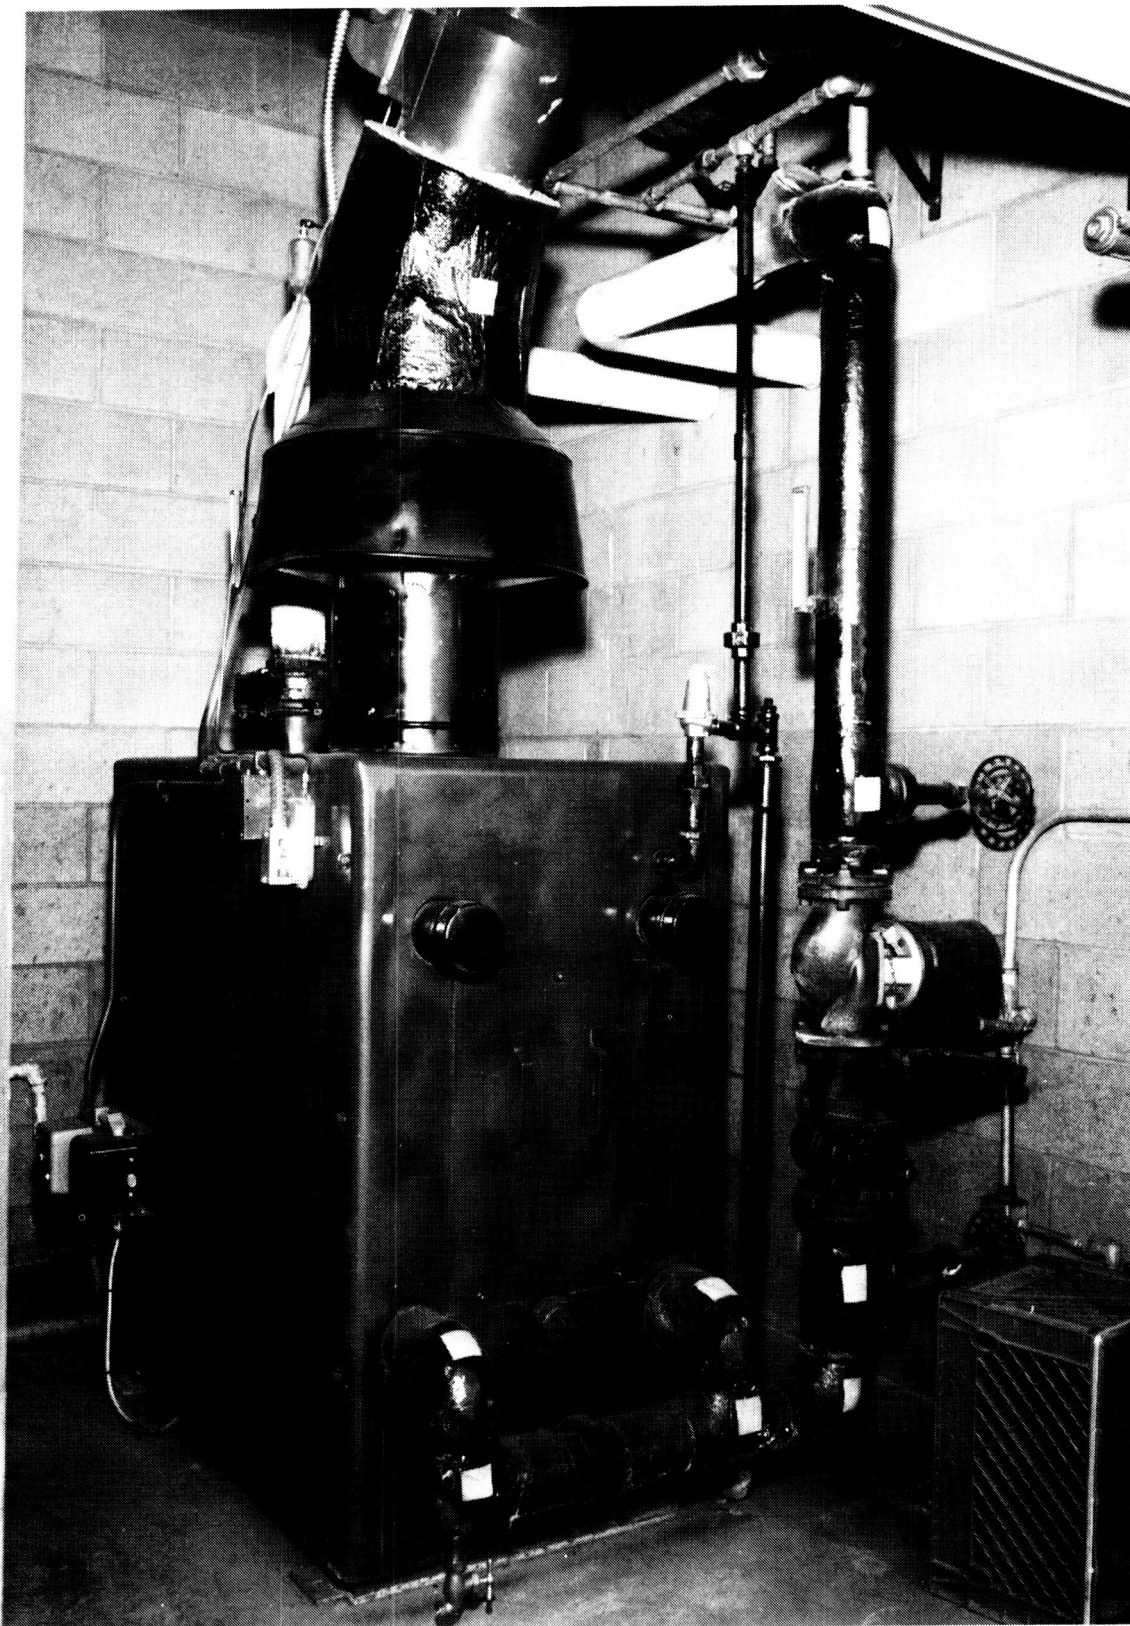
Figure 12. Echo Site: Building G-21, Boiler Room 128, Asbestos-Containing Pipe Lagging.

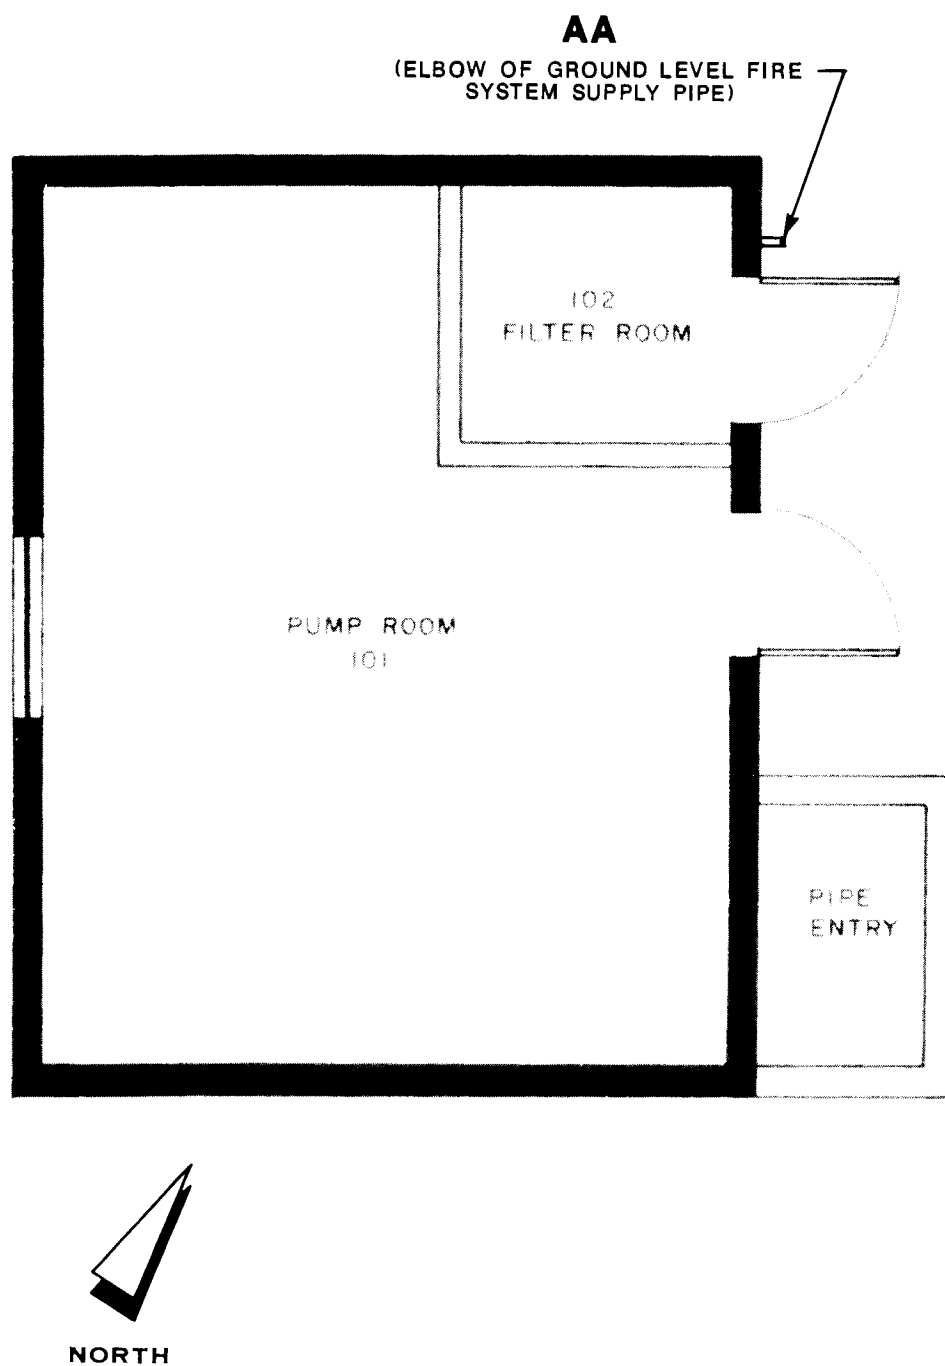
Figure 13. Echo Site: Fire Line Pump House G-22.

Comments: ELBOW HAS HARD CEMENTITIOUS MATERIAL WITH SOME ADDITIONAL USE EXTENDING AWAY FROM THE ELBOW. SEE FIGURE 13

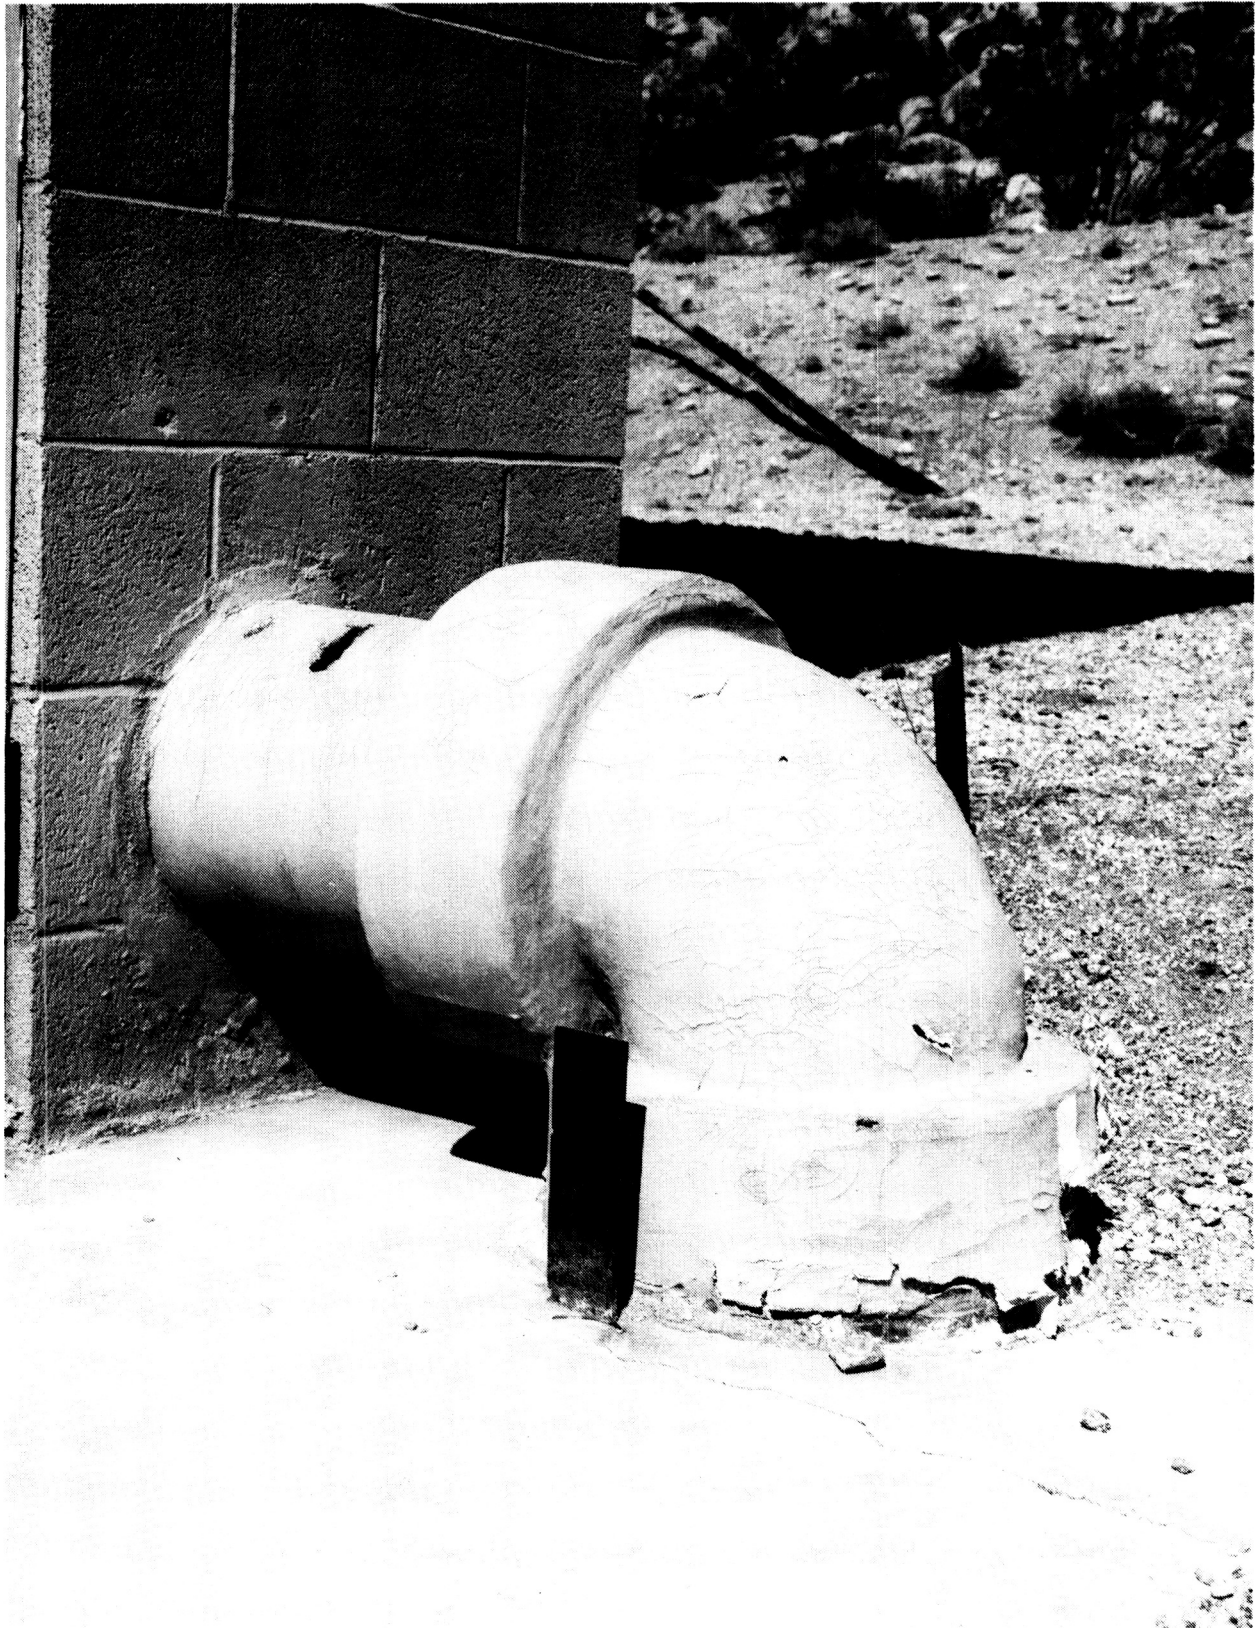
Figure 14. Echo Site: Asbestos-Containing Insulation around Fire System Water Supply Pipe Exterior to Fire Line Pump House G-22, Typical Asbestos-Containing Insulation Covering Exterior Pipes that Enter or Leave Buildings G-22, G-27, G-38, G-58 and M-6 at the GDSCC.

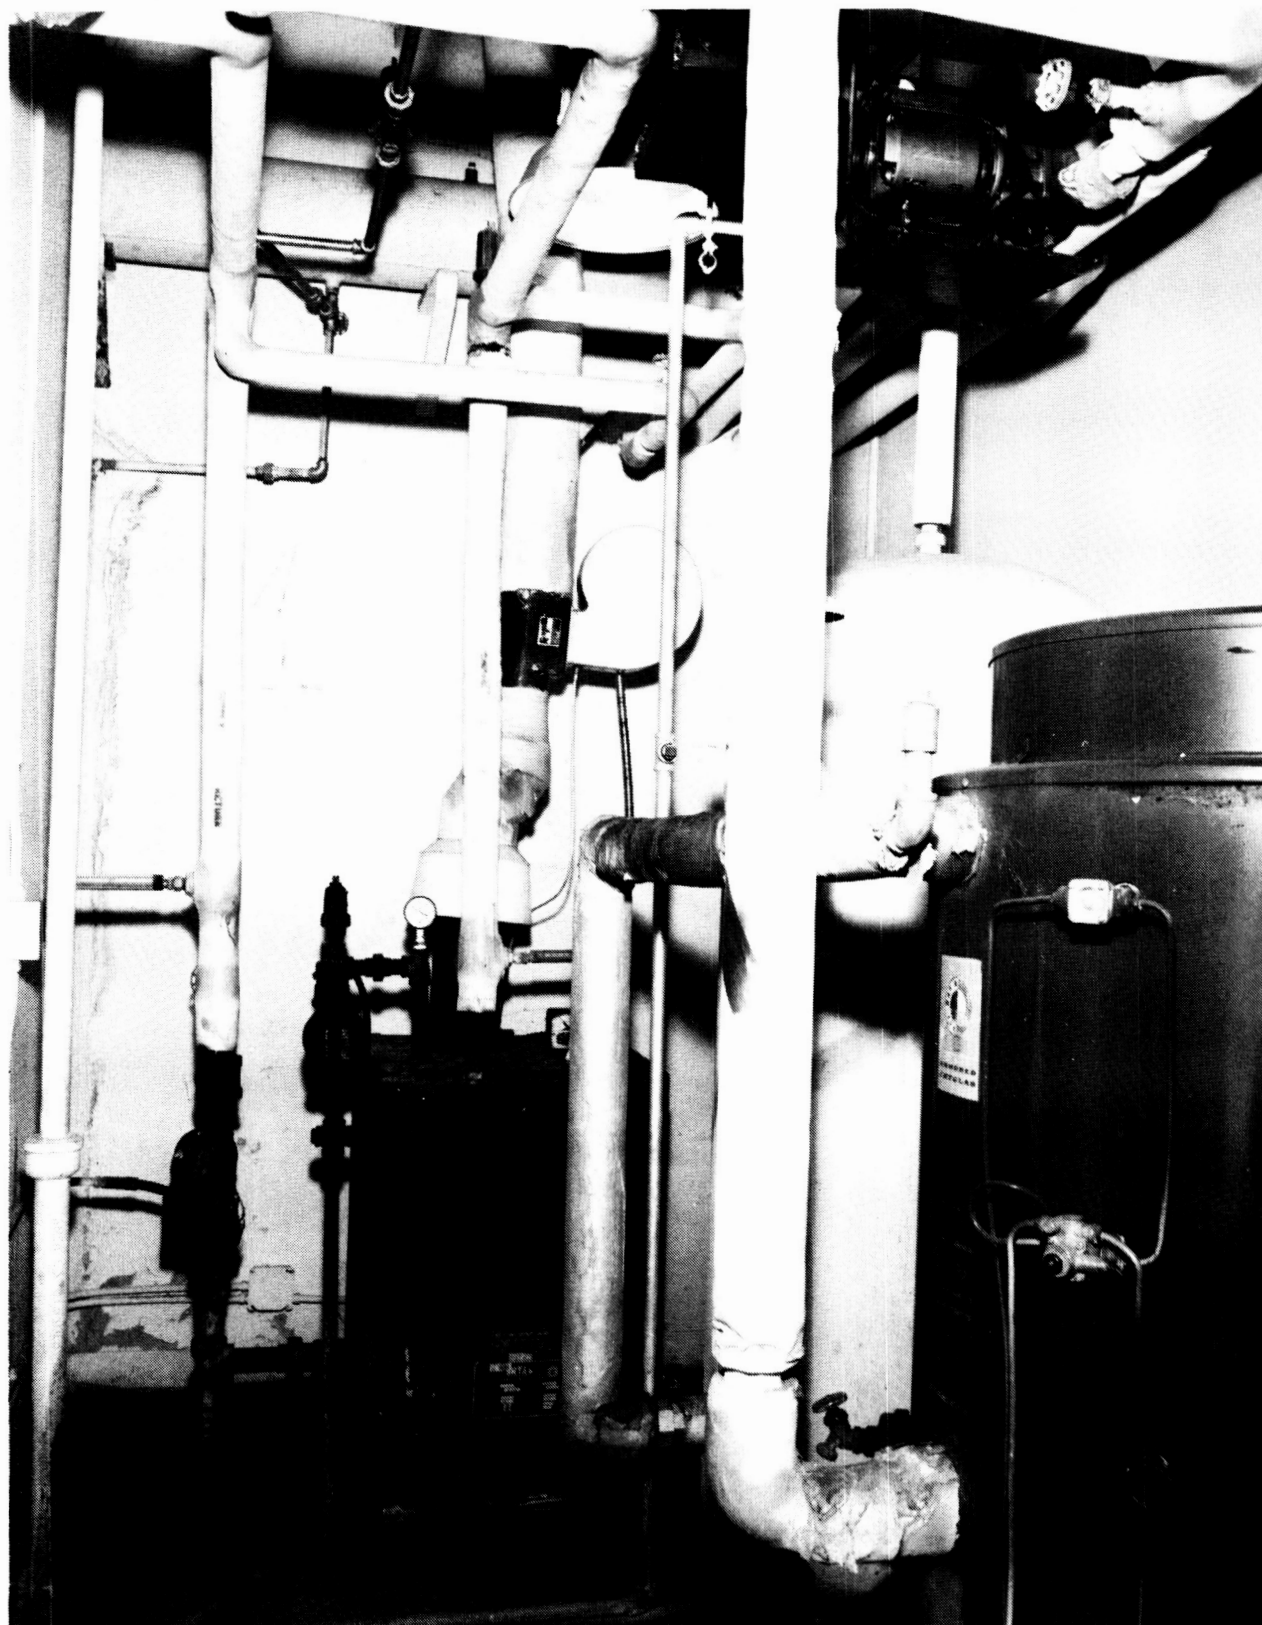
Figure 16. Echo Site: Building G-23, Boiler Room 107, Asbestos-Containing Pipe Lagging.

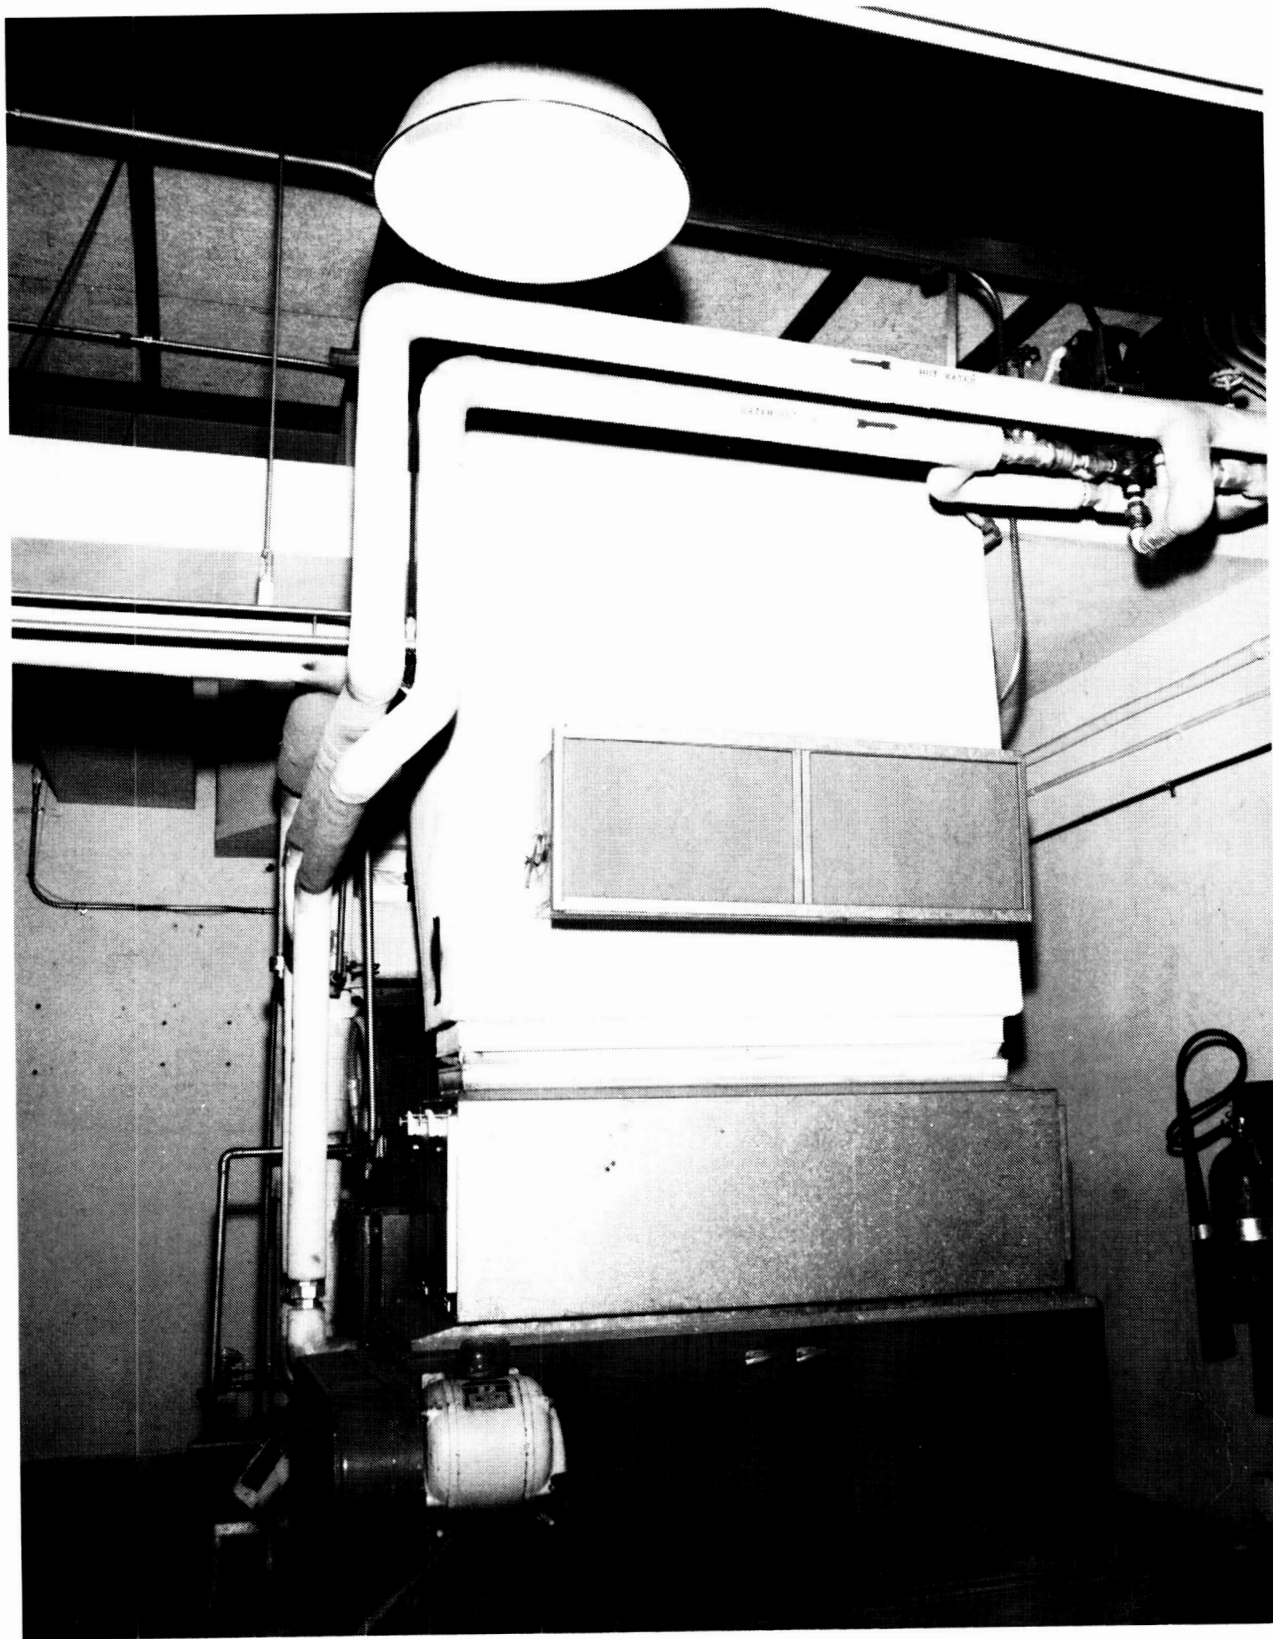
Figure 17. Echo Site: Building G-23, Mechanical Equipment Room 108, Asbestos-Containing Pipe Lagging.

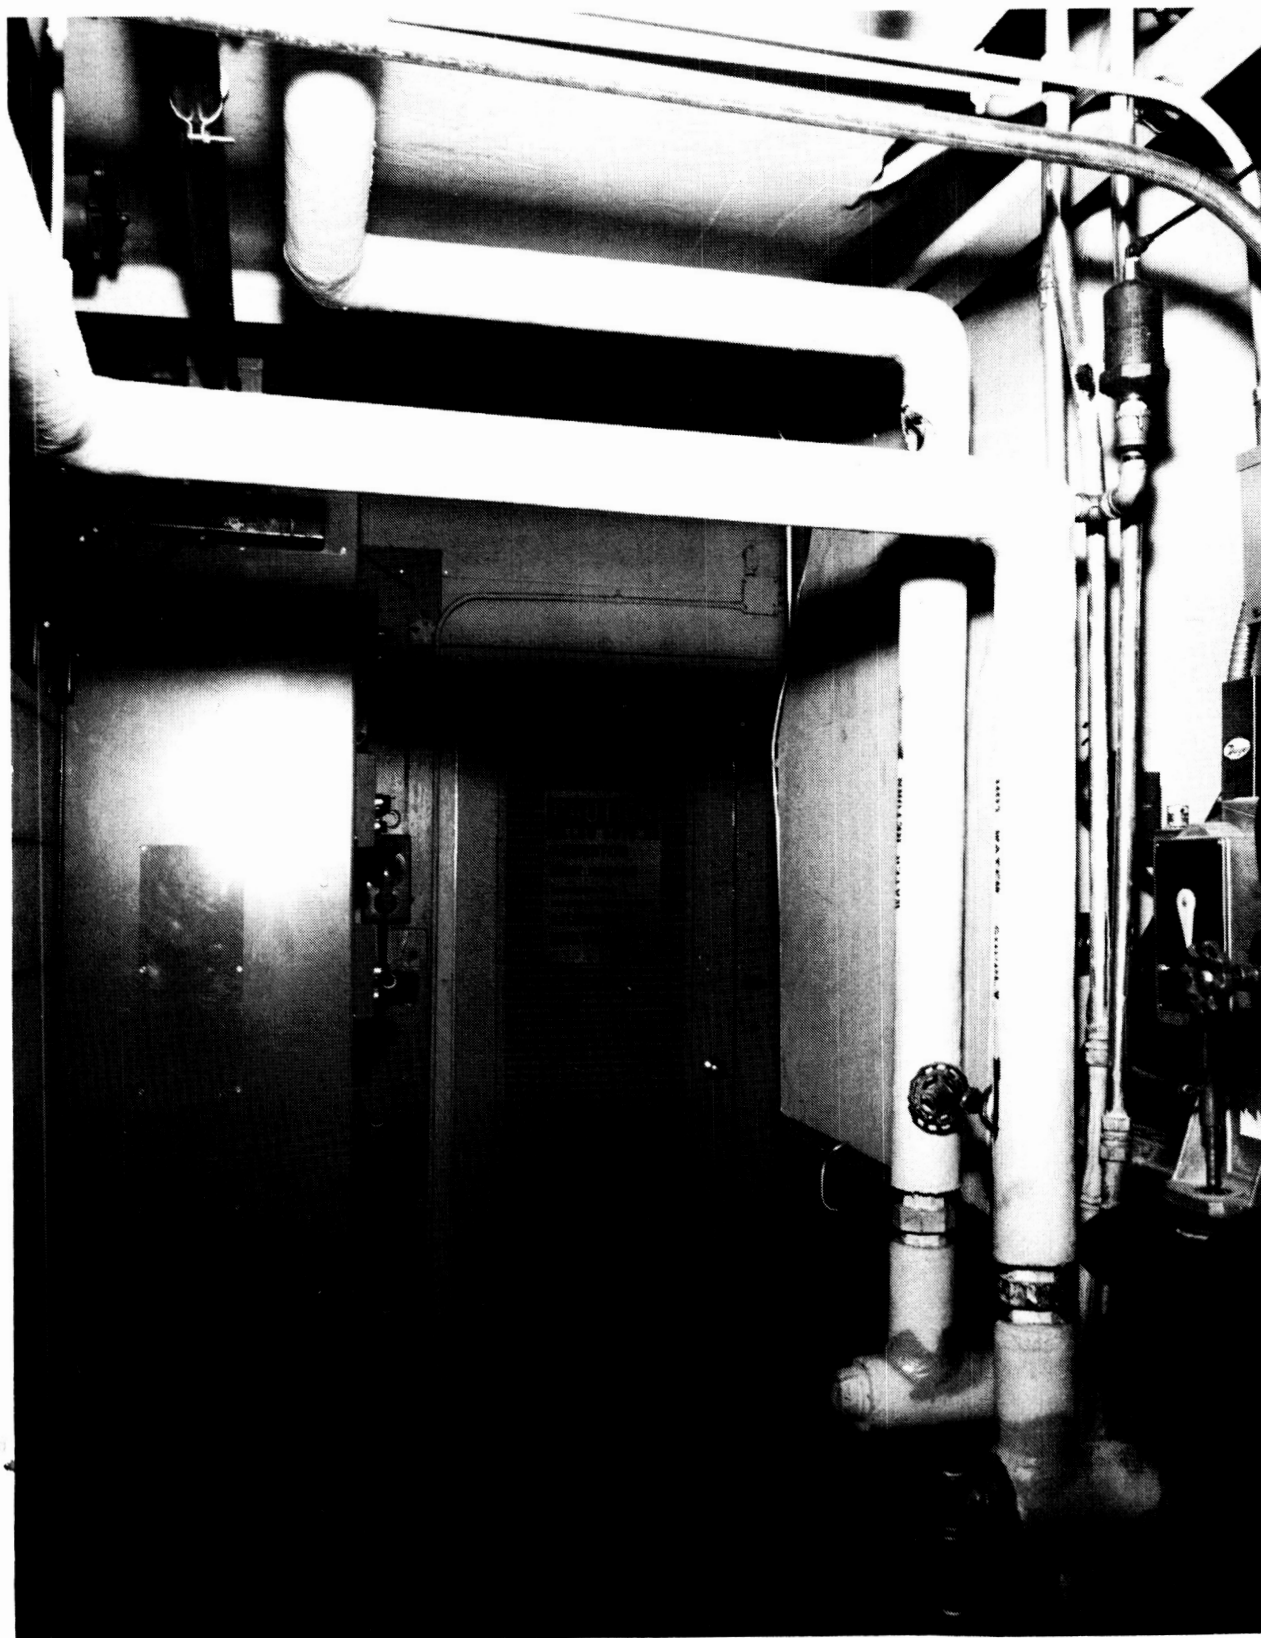
Figure 22. Echo Site: Building G-26, Mechanical Equipment Room 108, Asbestos-Containing Pipe Lagging.

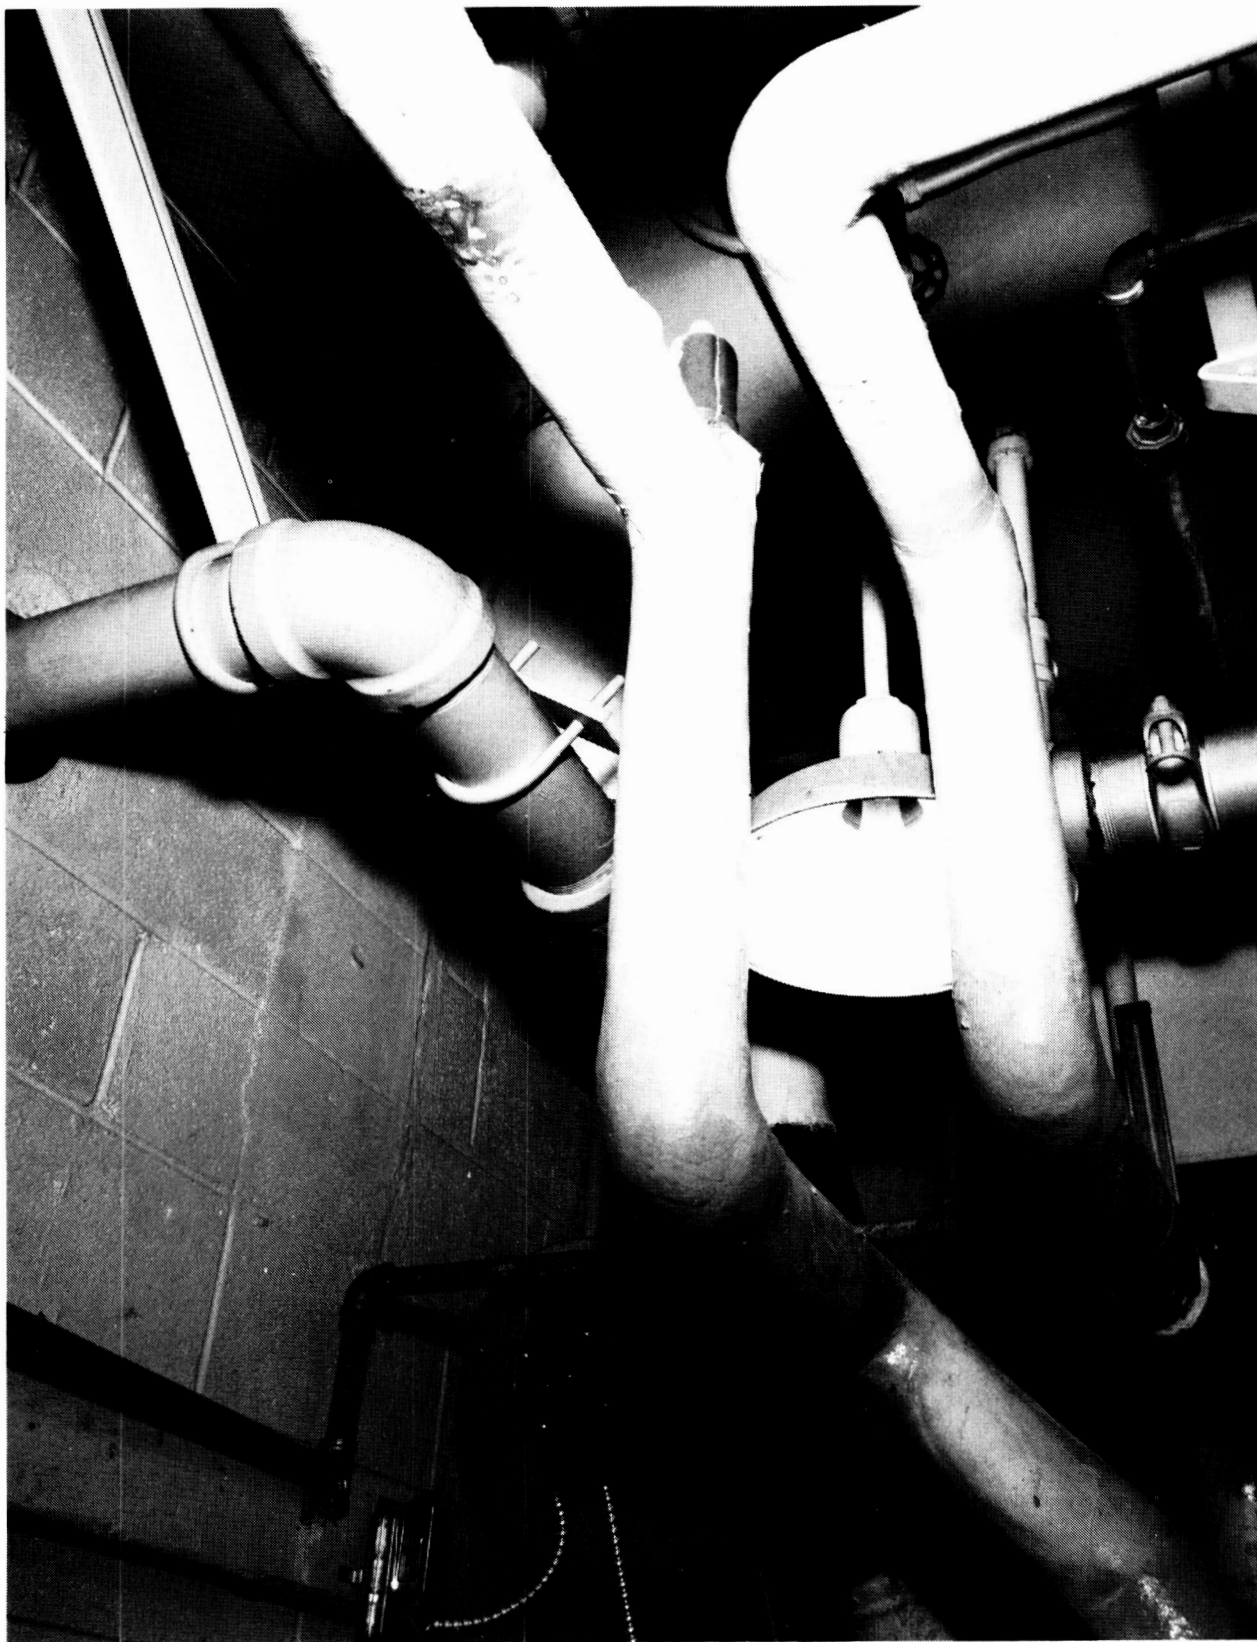
Figure 23. Echo Site: Building G-26, Boiler Room 110, Toward Ceiling, Asbestos-Containing Pipe Lagging.

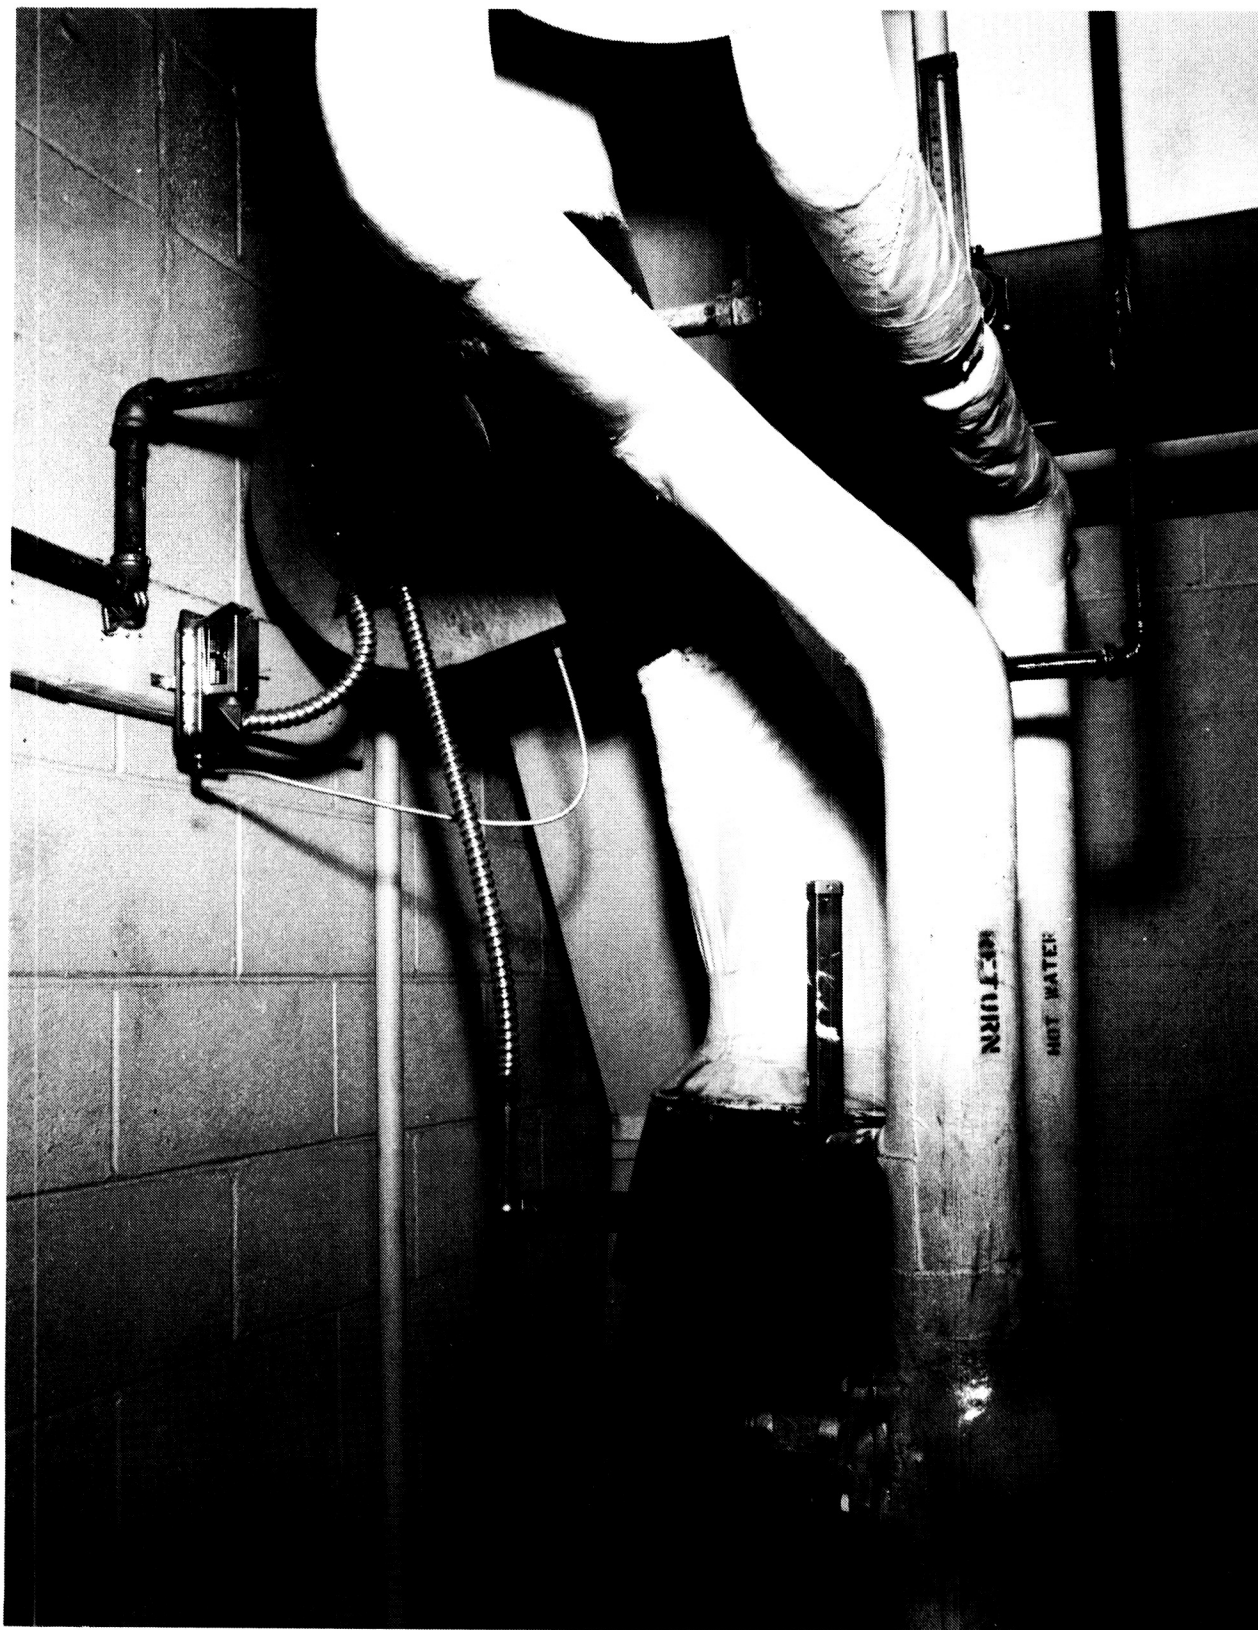
Figure 24. Echo Site: Building G-26, Boiler Room 110, Toward Floor, Asbestos-Containing Pipe Lagging.

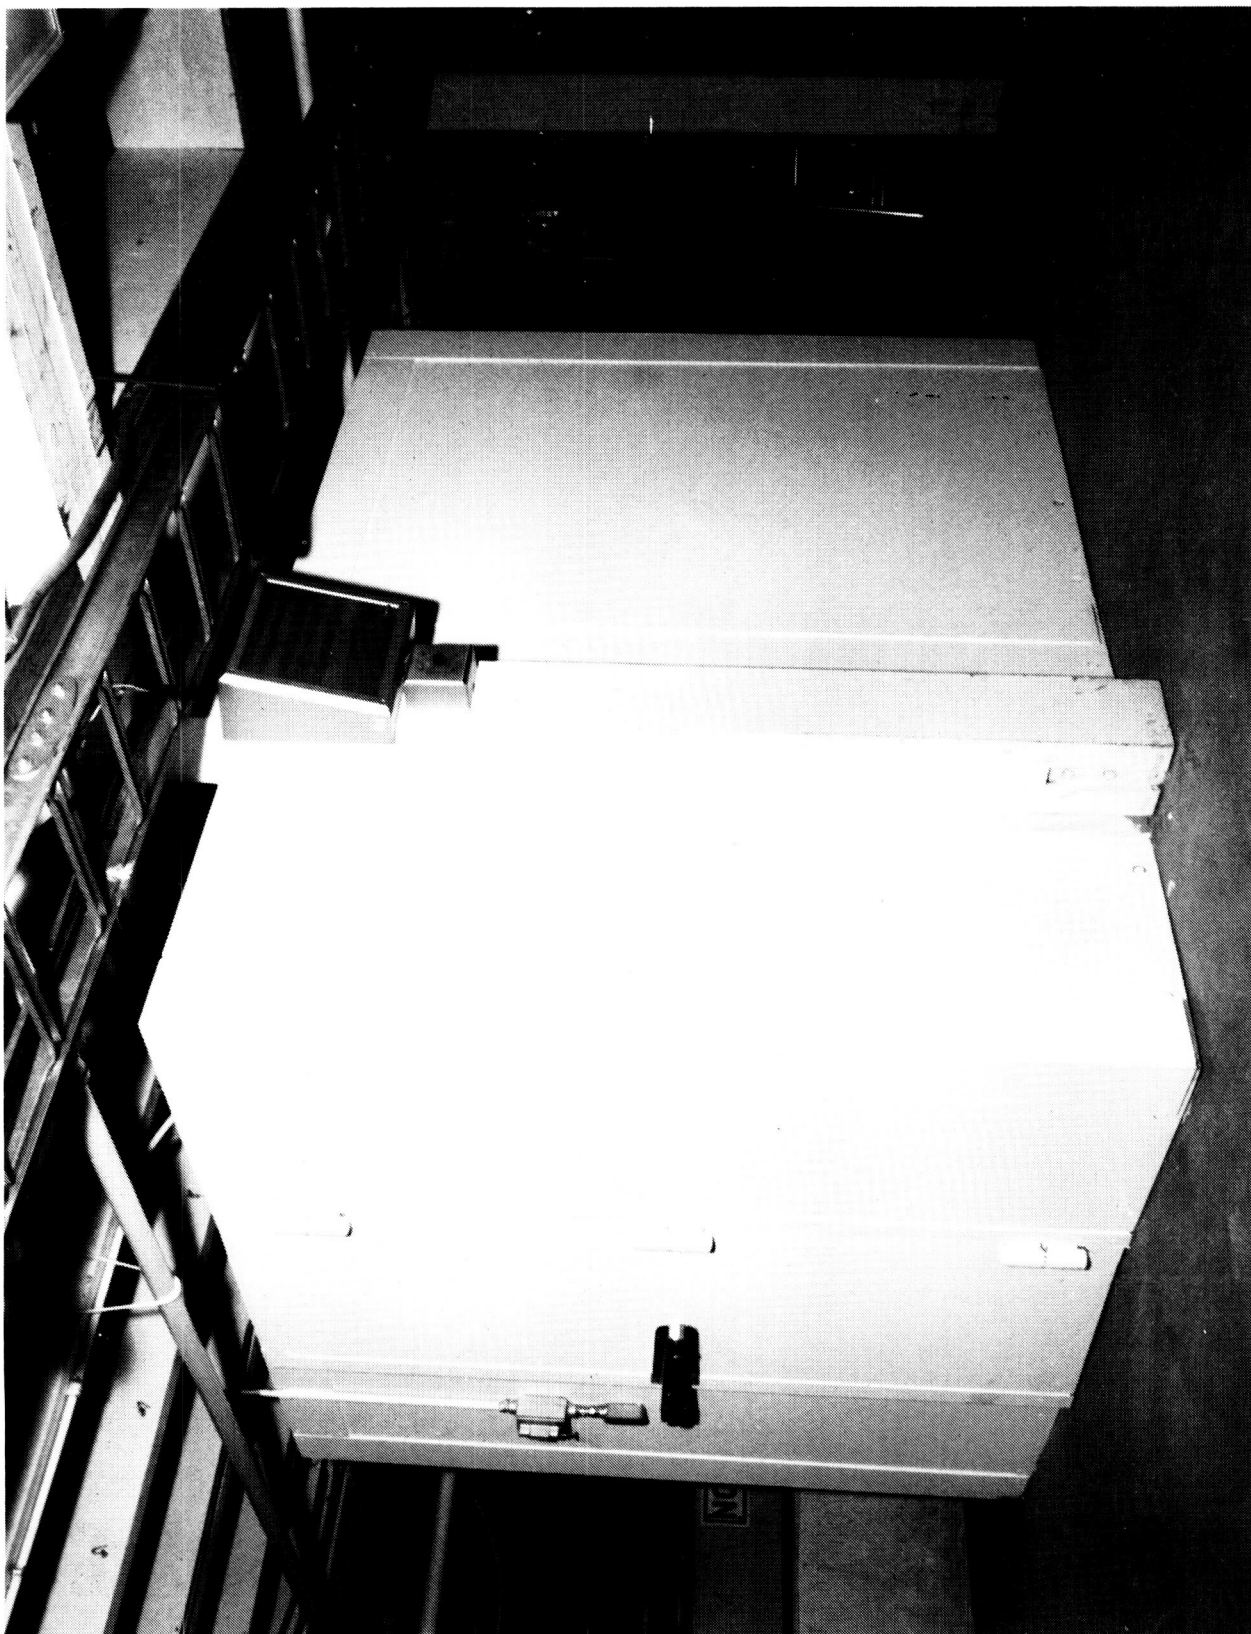
Figure 25. Echo Site: Building G-26, Tape Vaults Room 128P, Typical Tape Vaults  
Constructed of Asbestos-Containing Transite Board.
